# AIRCRAFT WORKSHEET

Reference: 150509

A/C  
Type: Rans S6 ESReg: **G-RTHS**

Serial No: PFA 204-14753

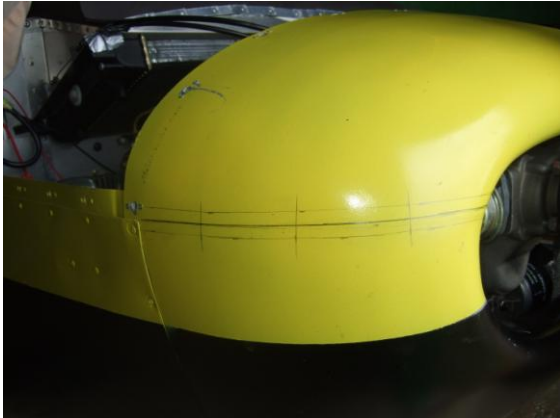
Mark put cut line and hole positions

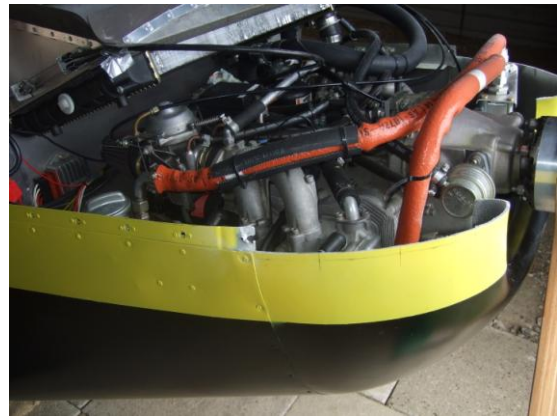
Cut nose bowl

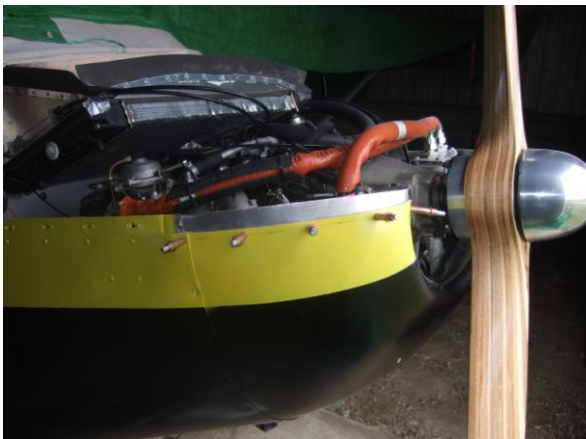
Cleco backing plate

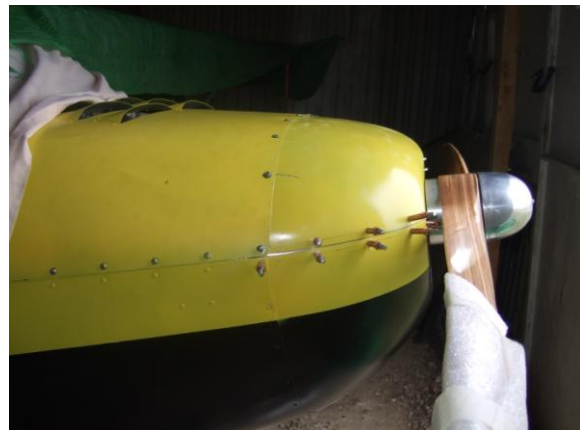
Cleco top cowling

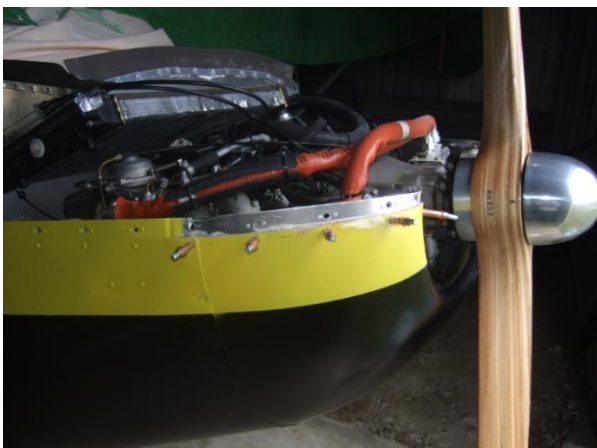
Fit fastener receptacles

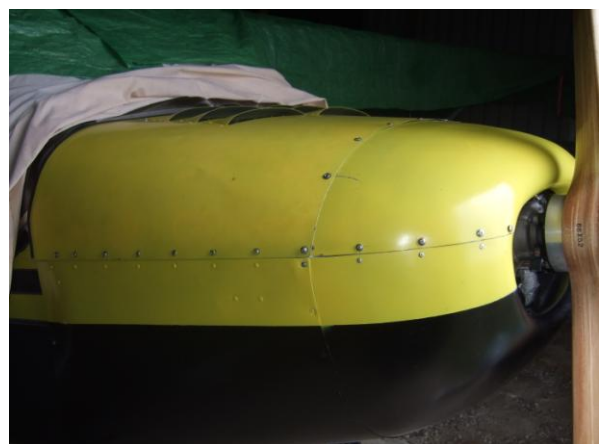
Finished result.
